Manhole Inspection Summary

Manhole # S31II_020MH

Location Address: **1401 LAFAYETTE AVE**

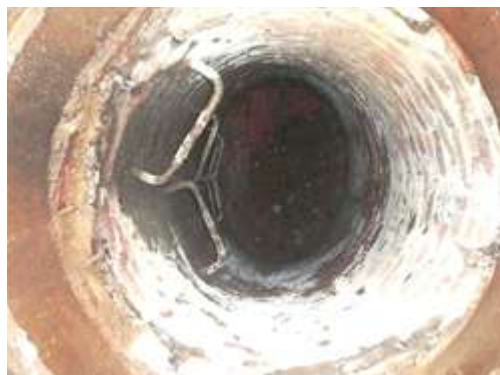
Top View

Corroded steps. Channel debris.

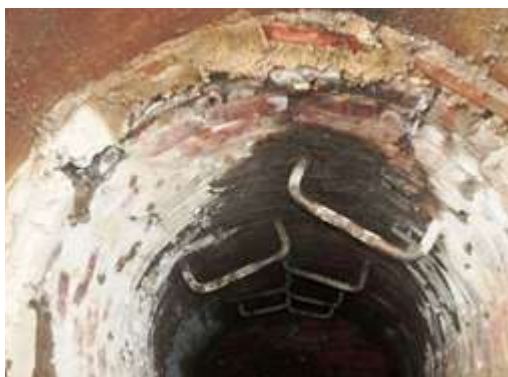
Defect

Frame leaks. Adjustment deterioration, loose brick and infiltration. Corbel and Barrel infiltration - other side.

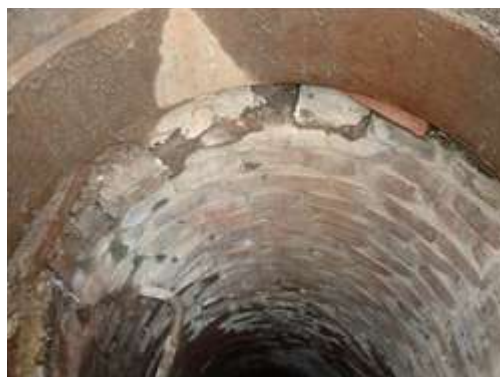
Defect

Frame leaks. Adjustment deterioration, loose brick and infiltration. Corbel and Barrel infiltration.

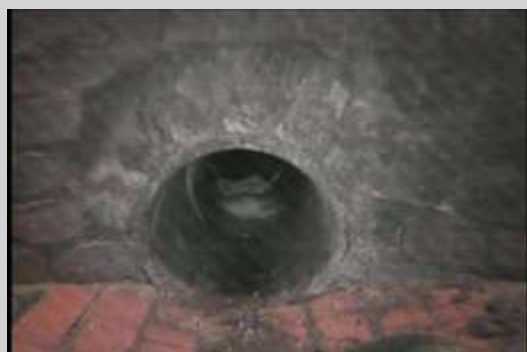
Pipe Out @ 12 O'Clock

8 in. Circular Gravity Sewer

Pipe Material: **Clay**

Invert Depth: **11.90** (ft.) Flow Characteristics: **None**

Infiltration: **None**
